Leziate & Ashwicken
Highways Summary

May 2021 (6th June 2021)

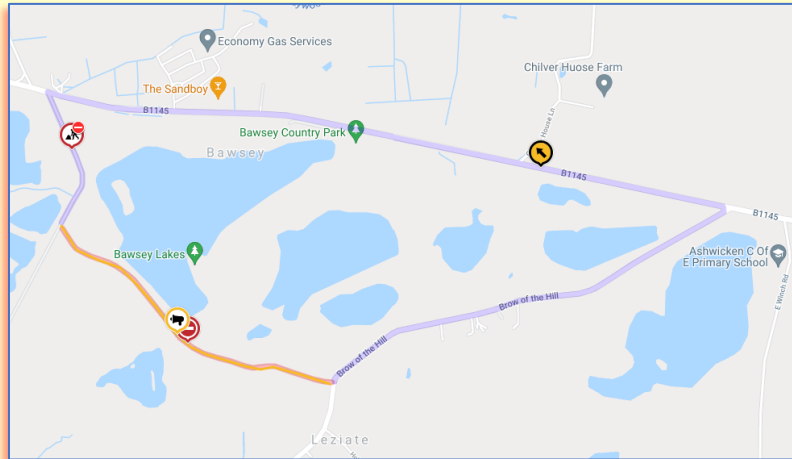
The closure is between the junction of Mintlyn Wood Rd with Brow of the Hill and near to the Sibelco Lime Silos and the diversion runs around Brow of the Hill and the B1145

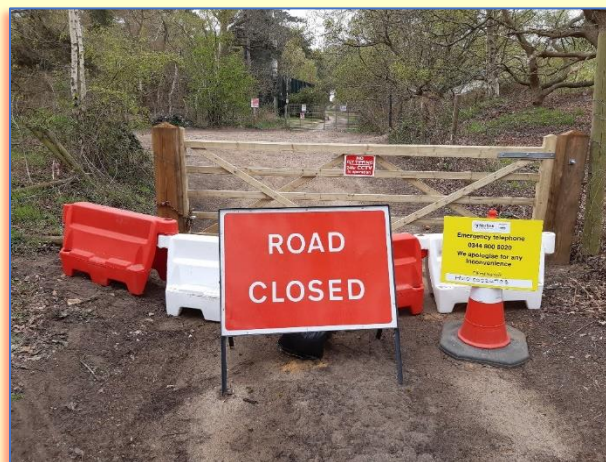
At the North Western / Sibelco lime silos end

Both ends of the closure have been blocked off with timber gates and temporary traffic management signs / barriers

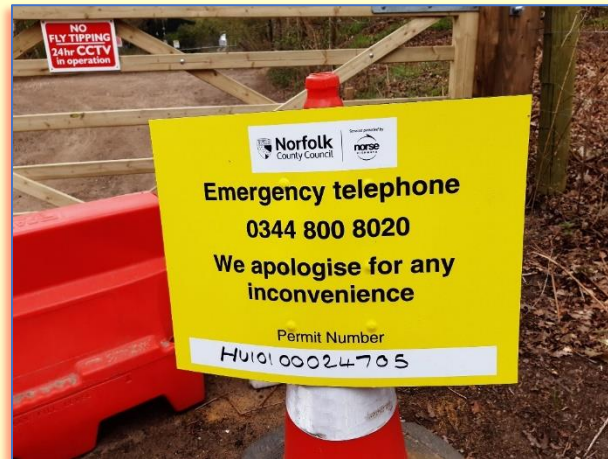
Site Notice posted at the North Western end

Closure Permit Notice number HU10100024705

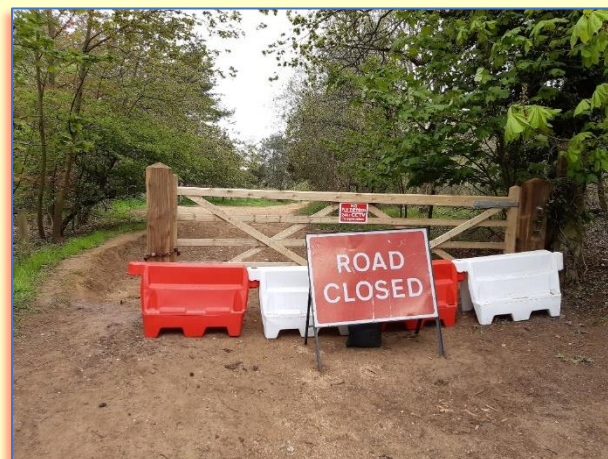
At the South Eastern / Brow of the Hill end

Observation;

Vehicles of visitors to the Bawsey Country Park have been observed parking in front of the gates at its junction with Brow of the Hill, potentially preventing access by emergency vehicles to Mintlyn Wood Road.
