Leziate & Ashwicken
Highways Summary

May 2021 (6th June 2021)

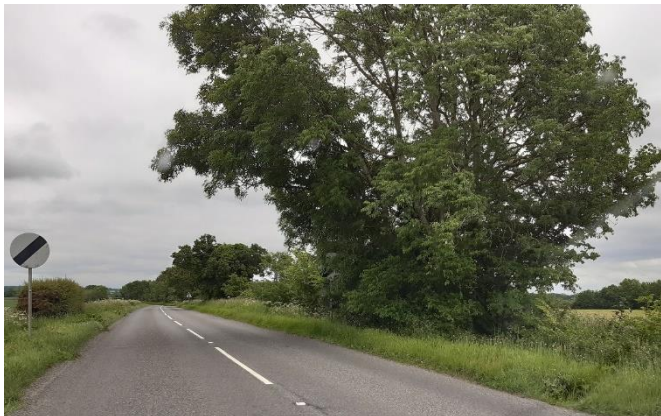
Ref	Location	Comment
B1145	Between Parish Boundary to the west (Bawsey) and junction with Brow of The Hill	Some minor damage noted to road edges Dumped rubbish behind bus stop No issues observed (29 th May)
B1145	Between junction with Brow of The Hill and East Winch Rd	W/B kerb offlet drains still blocked with detritus Otherwise, no issues observed (29 th May)
B1145	Between junction with East Winch Rd and Leziate Drove	E/B kerb offlet drains still blocked with detritus Otherwise, no issues observed (29 th May)
B1145	Between junction with Leziate Drove and Church Lane	No issues observed (29 th May)
B1145	Between junction with Church Lane and Fen Lane / Well Hall Lane	No issues observed (29 th May)
B1145	Between junction with Fen Lane / Well Hall Lane and Parish Boundary to the east (Gayton)	Vegetation obscuring E/B speed limit sign OK at present, but may need cutting back when the tree comes into leaf Report to NCC ref; ENQ900179209 <i>("We could not find the problem so have not taken any action at this time")</i> Reported again to NCC report ref;ENQ900187122

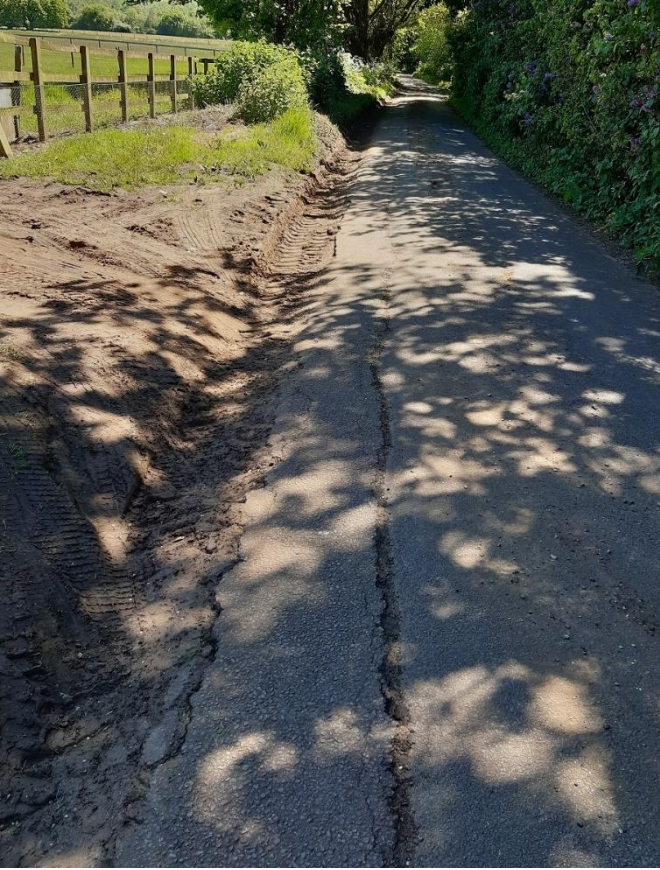
<p>Otherwise, no Issues observed (29th May)</p>
Church Lane	Between the Sewage Works and junction with East Winch Rd	<p>Pothole in the W/B near-side wheel track has been increasing in size during recent freeze-thaw conditions (near to solitary oak on the northern side of the road).</p> <p>Report to NCC ref; ENQ900179242; NCC Response; <i>We have inspected and are going to resolve the problem - After investigation we have confirmed action is required. Defects are scheduled for repair depending on the nature of the defect and work needed but on average can take approximately 6 weeks.</i></p> <p>No action has been taken yet. Otherwise, no Issues observed (29th May)</p>
Fen Lane	Between junction with B1145 and Leziate RB15 to Brands Wood	No Issues observed (29 th May)
